Long-Term Elimination of SAG Mill Feed Chute Blockages

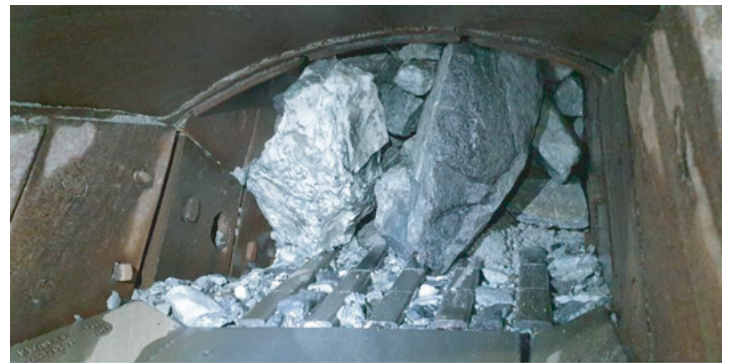
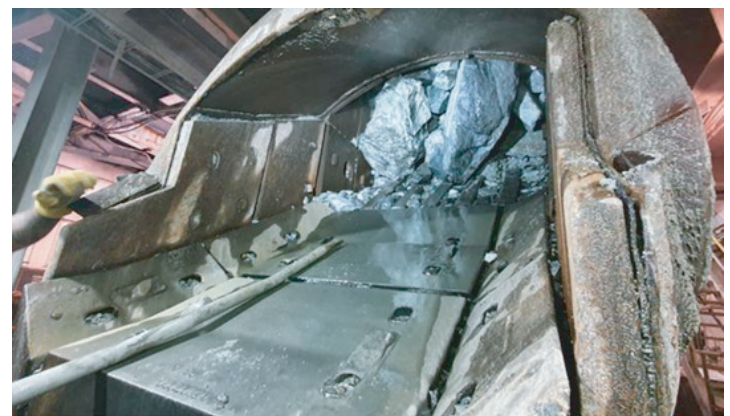
Makuri Technology was approached by a mining operation facing persistent blockages in their SAG Mill Feed Chute. The site was struggling with slabby ore material that regularly jammed in the chute, sometimes multiple times per day.

Each blockage event required a shutdown of the SAG mill to clear the obstruction – resulting in significant downtime, production losses, and safety risks to maintenance personnel working near confined spaces. The mine needed a long-term solution to improve flow reliability, reduce manual interventions, and extend operating uptime.

Makuri's team began by conducting an on-site evaluation and laser scan of the existing chute to obtain precise as-built dimensions. This allowed potential fitting challenges to be identified and resolved well in advance of installation.

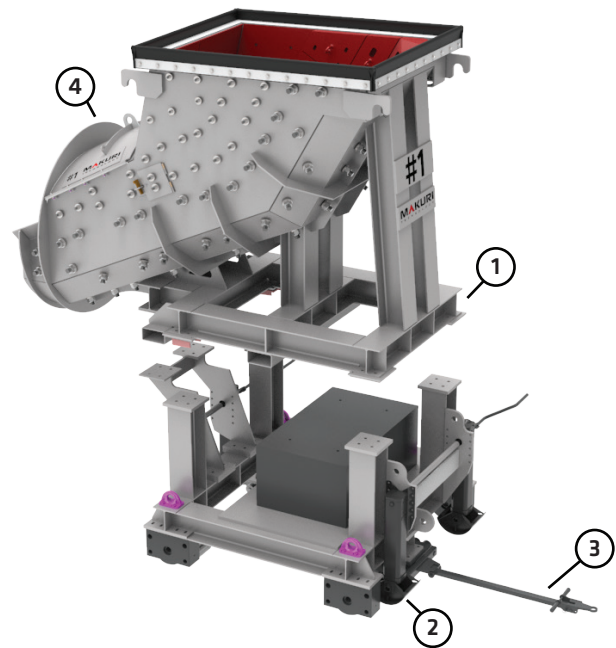
1. The chute assembly was modularized to simplify liner replacement and minimize exposure time for maintenance personnel.
2. Standardized off-the-shelf wheels and lifting jacks were incorporated, allowing the chute to be easily repositioned or maintained without the need for specialized lifting gear.
3. A third-party transport system was integrated to allow the chute to be moved around the site safely and efficiently during shutdowns or liner changes.
4. A second chute was fabricated and maintained on standby, enabling offline liner changeouts – meaning future replacements could occur outside of normal shutdown schedules, greatly improving plant availability.

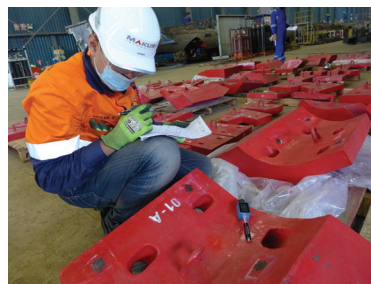
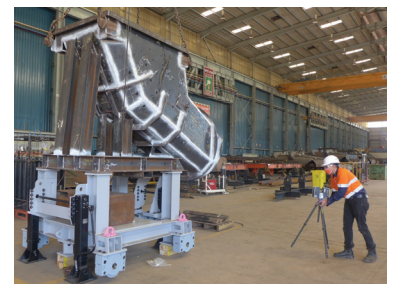
Makuri engineers also supervised all stages of manufacturing, ensuring adherence to design tolerances, material specifications, and welding standards. This end-to-end quality assurance process guaranteed that the chute would install and perform exactly as designed.
